# Manhole Inspection Summary

Manhole # S29OO1006MH

Insp Date: **7/2/07 12:23 PM**

**Location** Address: **4618 WILMSLOW RD**

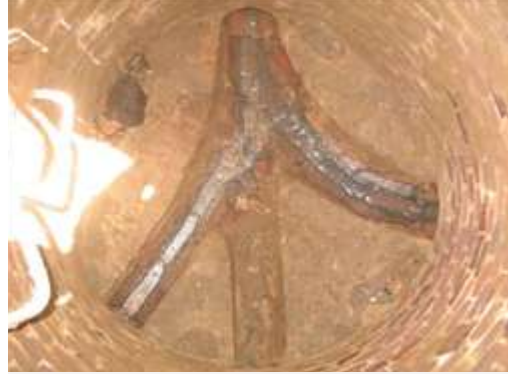
Top View

Adjustment infiltration. Bench and Channel debris.

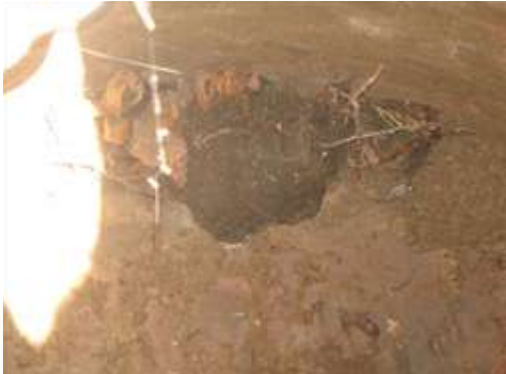
Defect

Barrel root intrusion.

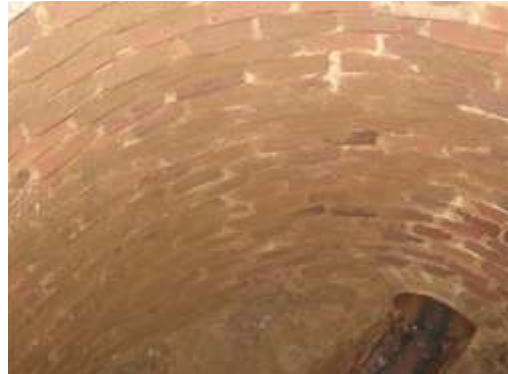
Defect

Barrel infiltration.

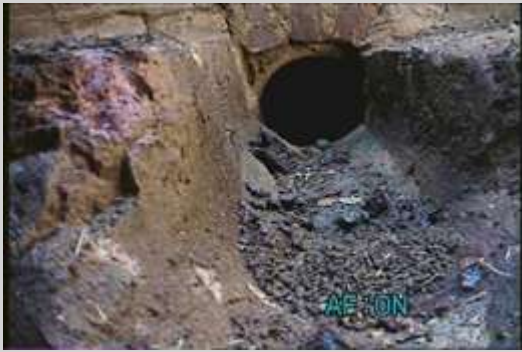
Pipe In @ 6 O'Clock

Bench deterioration.

Infiltration: **Evidence** Pipe Seal Cond: **Unknown**

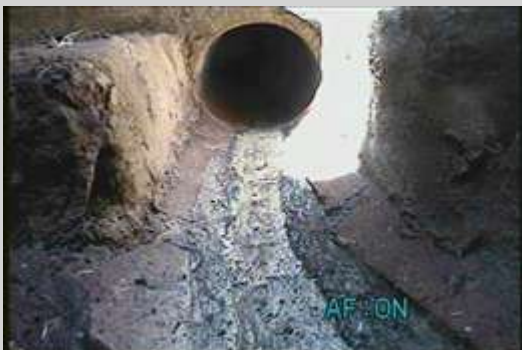
Pipe In @ 7 O'Clock

Infiltration: **Evidence** Pipe Seal Cond: **Unknown**
